# 750V, 750V-SS and 751V Dispense Valves

## Maintenance & Parts Guide

# Valve Disassembly and Reassembly Procedures

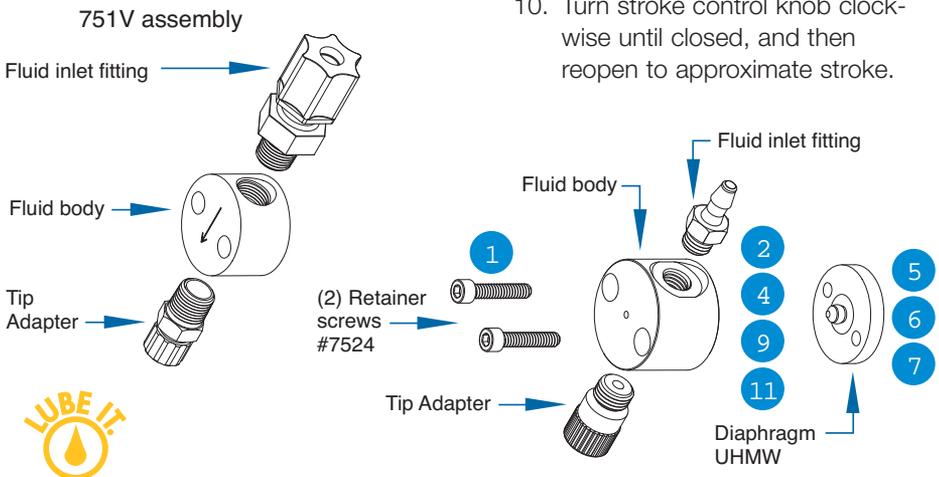
3. Back-out stroke control knob two turns counterclockwise from the closed position.
4. Remove fluid body.
5. Unscrew diaphragm (counterclockwise) and remove it from the piston rod.
6. Thread-on the new diaphragm and tighten with medium pressure.
7. Align the holes of the diaphragm with the appropriate holes in the air cylinder body by inserting a flat tip screwdriver through the hole in the stroke control knob and engage piston rod slot.
8. Rotate rod, piston and diaphragm assembly clockwise until holes are aligned.
9. Reinstall fluid body.
10. Turn stroke control knob clockwise until closed, and then reopen to approximate stroke.

1. Remove the two retainer screws.
2. To reinstall the fluid body, align fluid body holes with diaphragm and air cylinder body holes and reinsert retainer screws. Tighten in accordance with the following torque specifications:

11. Remove fluid body and diaphragm.
12. Remove stroke control knob and spring by turning counterclockwise.
13. Remove the piston retainer ring and anti-torque washer.
14. Remove the piston.
15. Lubricate O-ring, piston shaft and air cylinder wall with Nye Lubricant #865.
16. Reinstall components in reverse order of disassembly.

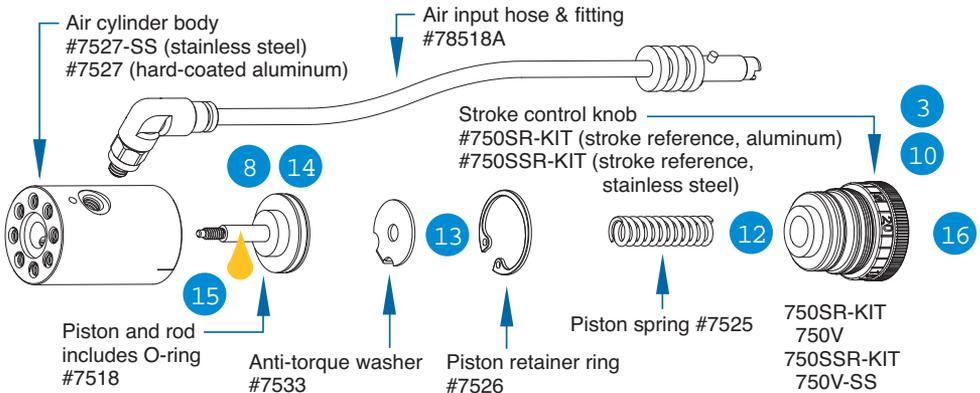
## Replacement Parts for Specific Valve Models

Model	Fluid Body			Fluid Inlet Fitting	Tip Adapter	Diaphragm
	UHMW	Acetal	Stainless*			
750V & 750V-SS	7521	n/a	7521-SS*	7511BP (1/8" ID Tube)	7514	7510
751V	n/a	7521D	7521D-SS	7611BP (1/4" OD Tube) 7610BP (3/8" OD Tube)	7514B	7510
